AD NO. _____
TECOM PROJECT (TRMS) NO. 7-CO-MI7-AP1-001
REPORT NO. USACSTA-6338

METHODOLOGY INVESTIGATION

FINAL REPORT

AUTOMATIC MAGNETIC RECORDING BORESCOPE

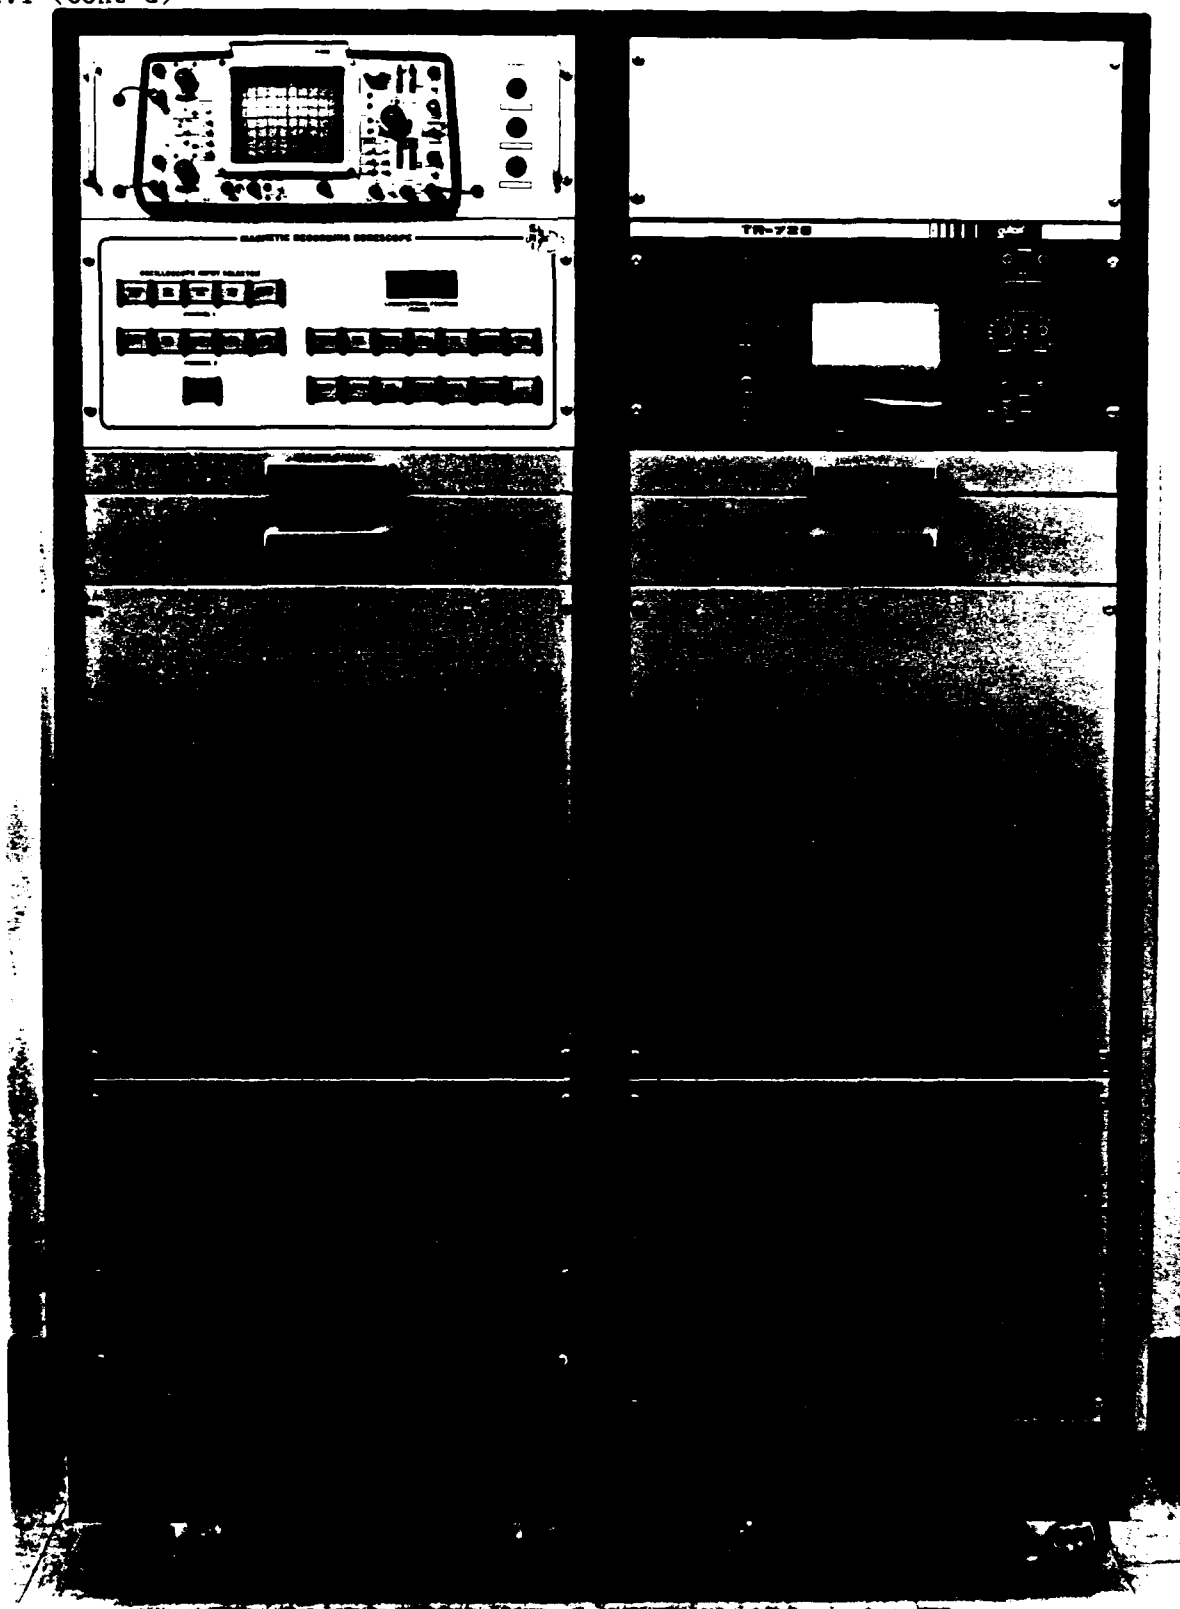
Figure 1.1-2. Control console.

APG, in collaboration with Watervliet Arsenal, has developed an improved system for nondestructive inspection of gun tube bores employing magnetization of the ferromagnetic gun tube material (fig. 1.1-1 and 1.1-2). Various versions of gun tube inspection systems with increased functional capabilities have been built. However, even the most recent model of the magnetic recording borescope (MRB) had less capability than desired and had performance limitations which decreased system effectiveness. This project was initiated to overcome these limitations and to increase system capability.

The control console houses the control panel, an oscilloscope, a strip-chart recorder, control logic, signal-conditioning circuitry, and system power supplies and provides storage for the longitudinal-drive adaptors. Pushbutton switches on the control panel facilitate selection of oscilloscope input signals and actuation of longitudinal and rotary motion of the inspection head. Indicators show various types of detection and alarm events.
